TECHNICAL BRIEF | #2011-05

“Original State” of Concrete / Clay Roof Tile Being Shipped from a Manufacturing Facility

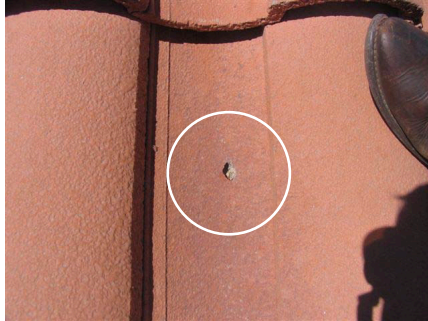
During hail events, damage to tile can occur in numerous forms. It can produce visible cracks at overlaps, produce chips at the perimeter edges of the nose of the tiles, create blowout on the backside that will appear as holes and create surface cracking from the impact of the hail stones that are not uniform in geometry and often have pointed crystalline designs moving at terminal velocity upon impact to the roofing surface.

Picture of hail damage creating blow out

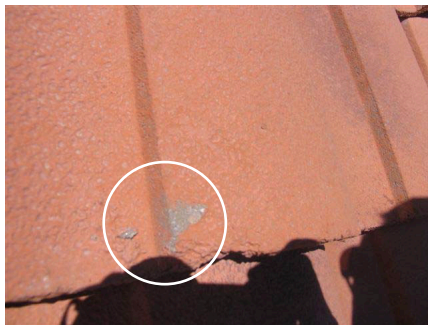
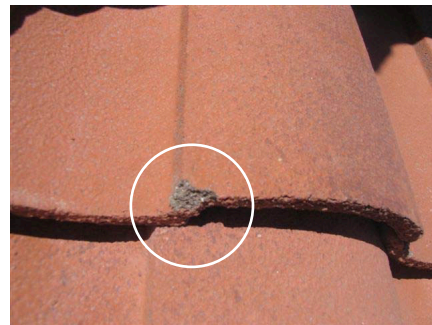
Pictures of chipping to edge of slurry-coated tile

Is there a limit as to how large a chip can be before it affects the integrity of the roof? Please refer to the workmanship standards of the appropriate state where your roof system is installed along with the TRI Alliance. Certain states such as Arizona ROC state that a tile with a chip greater than the size of a quarter must be replaced. If the tile is cracked, chipped or broken across the face of the tile in either direction, it should be replaced.
