TECHNICAL BRIEF | #2019-01

Hip and Ridge Mortar Generated Surface Efflorescence

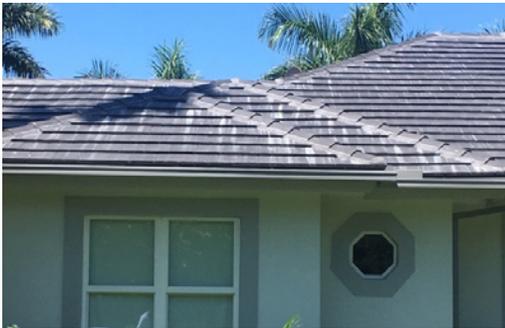
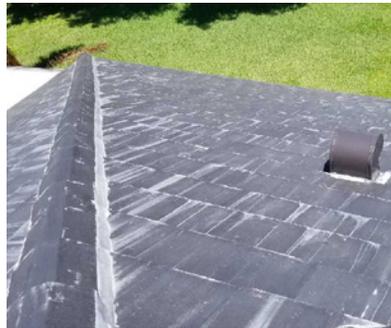
Efflorescence is caused by the chemical nature of the cement. Manufactured cement contains free lime, and when water is added, a series of chemical reactions take place. These reactions are accompanied by the release of calcium hydroxide, which can form an overall "white chalky" crystalline salt deposit on the tile surface when reacting with carbon dioxide. This reaction can appear as an overall "bloom" (overall softening of color) or in more concentrated patches.

Picture of superficial efflorescence caused by the mortar installed at the ridge.

It is difficult to predict how long the effects of efflorescence will last. It depends on the type and amount of deposit as well as the local weather conditions. In most cases the action of carbon dioxide and rainwater will gradually remove the deposit.

The manufacturer of the mortar materials may help provide additional methods for reducing, sealing or cleaning efflorescence created by their products.
